Signal and Train Control Factual Report

**Rear-End Train Collision on the Norristown High Speed Line**

**Southeastern Pennsylvania Transportation Authority**

**DCA 17 FR 012**

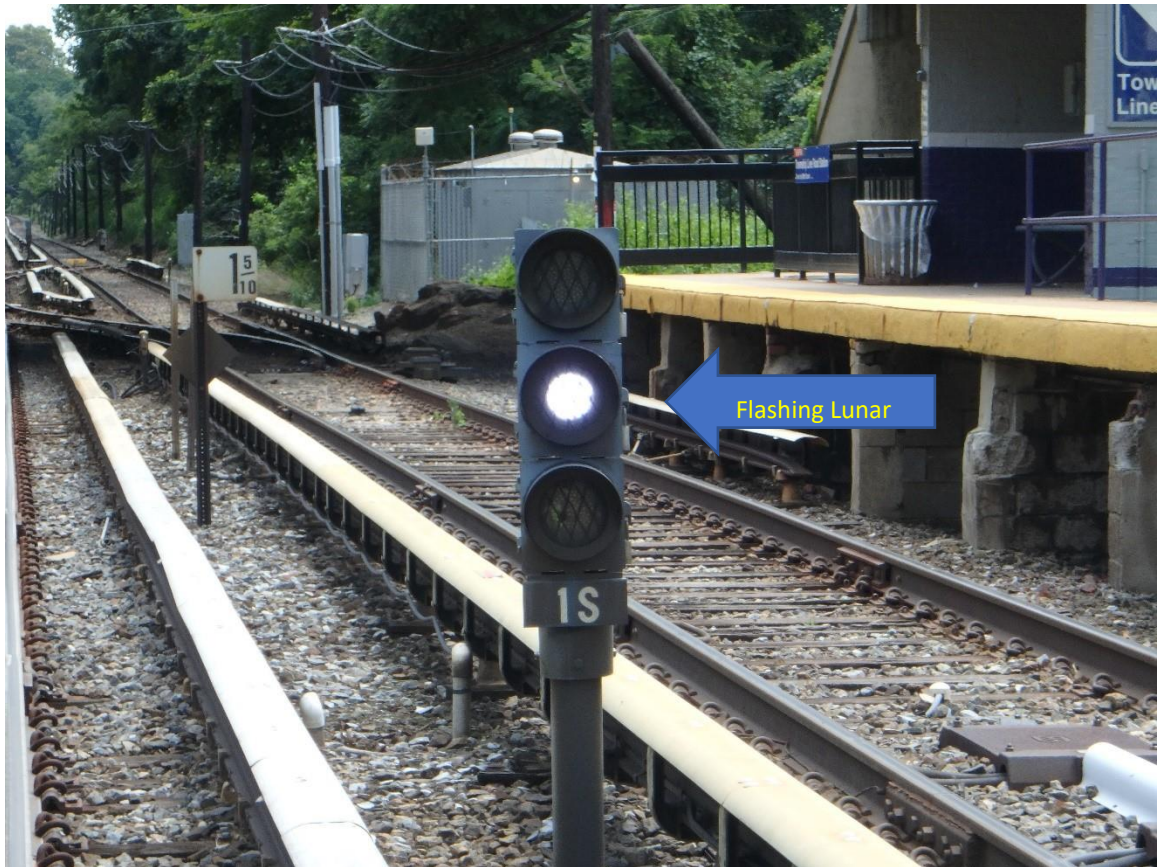
*Figure 1 Flashing Lunar 1S West Overbrook Interlocking*

| <p>12:08:29</p> | <p>Train 155 is occupying south approach on main track one at West Overbrook Interlocking. 1S signal has a signal indication of flashing lunar. The 21 X-over switch is lined reverse to allow a train to move from main track one to main track two. See figure - 1.</p> <p>Note : time adjusted 2min 4 sec to synchronize time with 69<sup>th</sup> street data recorder.</p> | <p>75</p> | <p><u>15 MPH</u><br/> Indication/Procedure: The 15 MPH aspect will illuminate. Train Operators must maintain a speed of 14 MPH or less.</p> |

The route was duplicated of the striking train 155 from the 1S signal at West Overbrook Interlocking to the 6S signal at 69<sup>th</sup> street. Each signal was photographed with the same aspect displayed as train 155 had on August 22, 2017.

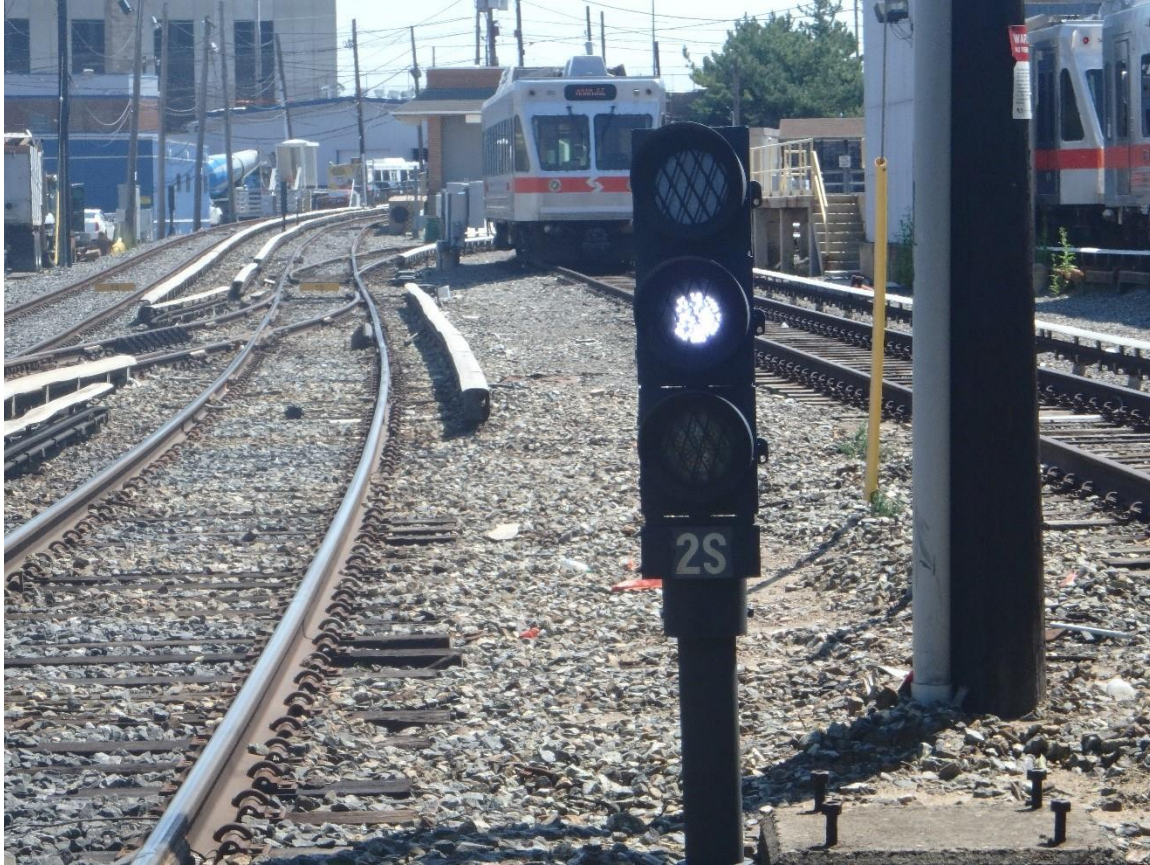
*Figure 2 Lunar 2S signal 69th Street Terminal*

| Time | Event | Corresponding Cab Code Rate<br>Pulses Per Minute | On Board Cab Signal Indication |
|---|---|--|--|
| 12:10:26 | Train 155 is occupying the south approach of the 2S signal on main track two. The 2S signal is indicating Lunar. The on-board Cab signal code rate is 120 with an allowable speed of 30 MPH See Figure -2 | 120 | <p><b>30 MPH</b><br/> <b>Indication/Procedure:</b> All aspects up to and including the 30MPH aspect will illuminate. Train Operators must maintain a speed of 29 MPH or less.</p> |

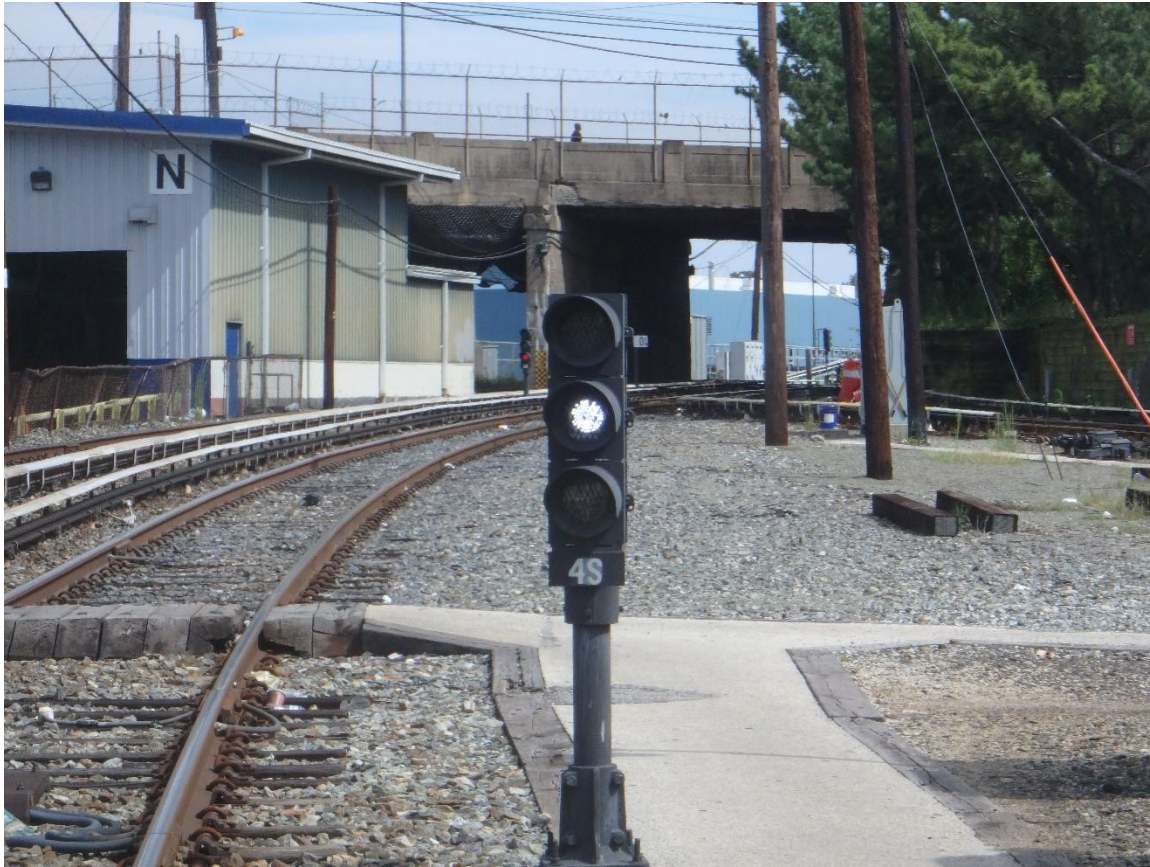
*Figure 3 Lunar 4S Signal 69th Street Terminal*

| Time | Event | Corresponding Cab Code Rate<br>Pulses Per Minute | On Board Cab Signal Indication |
|---|---|--|--|
| 12:10:49 | Train 155 is occupying the south approach of the 4S signal on main track two. The 4S signal is indicating lunar. The On-board Cab signal code rate is 75 with an allowable | 75 | <p><b>15 MPH</b><br/> <b>Indication/Procedure:</b> The 15 MPH aspect will illuminate. Train Operators must maintain a speed of 14 MPH or less.</p> |

| <b>Time</b> | <b>Event</b> | <b>Correspondin<br/>g Cab Code<br/>Rate<br/><br/>Pulses      Per<br/>Minute</b> | <b>On Board Cab Signal Indication</b> |
|---|---|---|---|
| | See Figure3 | | |

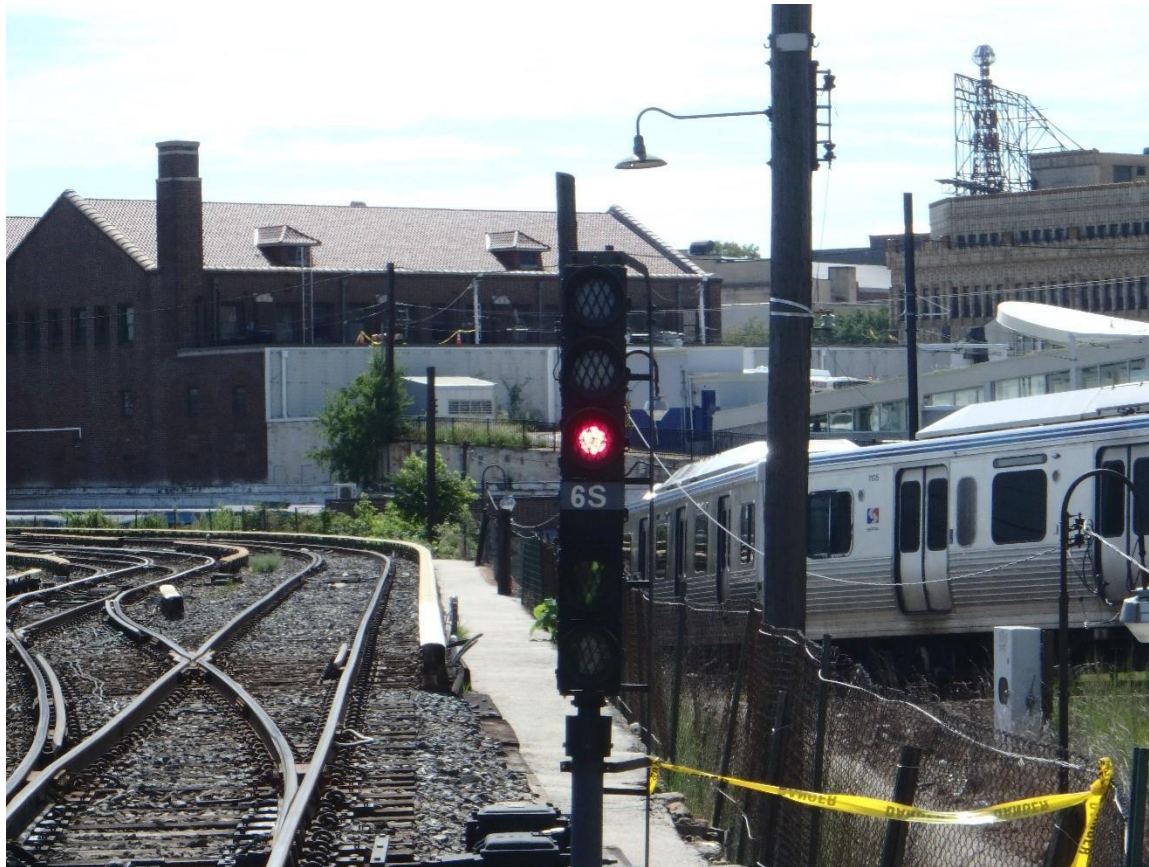
*Figure 4 6S Signal with Red aspect indicating stop with 0 Cab Code Rate*

| 12:10:59 | Train 155 is occupying the south approach of the 6S signal on main track two. The 6S signal is indicating red. The On-board Cab signal code rate is 0 with an allowable speed of 0 MPH See figure -4 | | <p><u>RDR-353 C. - No Code</u></p> <p><b>Indication/Procedure:</b> Train Operator must come to a complete stop and unless otherwise specified contact Control Center for instructions prior to moving the train. When permission has been granted, depress the stop/proceed button. Train Operator must then proceed at Restricted Speed until receiving a more favorable cab or fixed signal.</p> <p><b>Aspect:</b></p> |

Postaccident examination of signal 6S and signal operational tests indicated the system was functioning as designed.
